THE CATHEDRAL CHURCH OF St PATRICK, KILLALA

THE BUILDING & GROUNDS

Excerpt from the 2005 Conservation Report by Nicholas Prins, MA (Oxon) MSc (Lond)

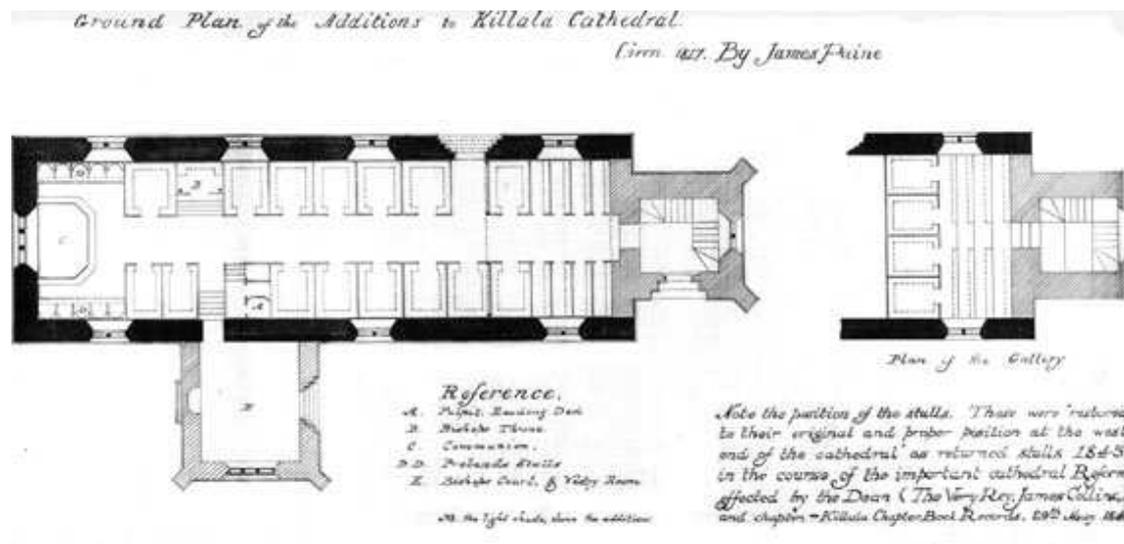
³ Ground Plan of Additions to Killala Cathedral circa 1817 by James Paine (framed document on wall of cathedral vestry) [included in this document]
